Surface Examination Report

Mineral Mountain, Ranch Canyon, State Volcanic Material Leases
Beaver County, Utah

Date of Inspection: June 19, 1995

Conducted by: William M. Stokes, SITLA, Minerals

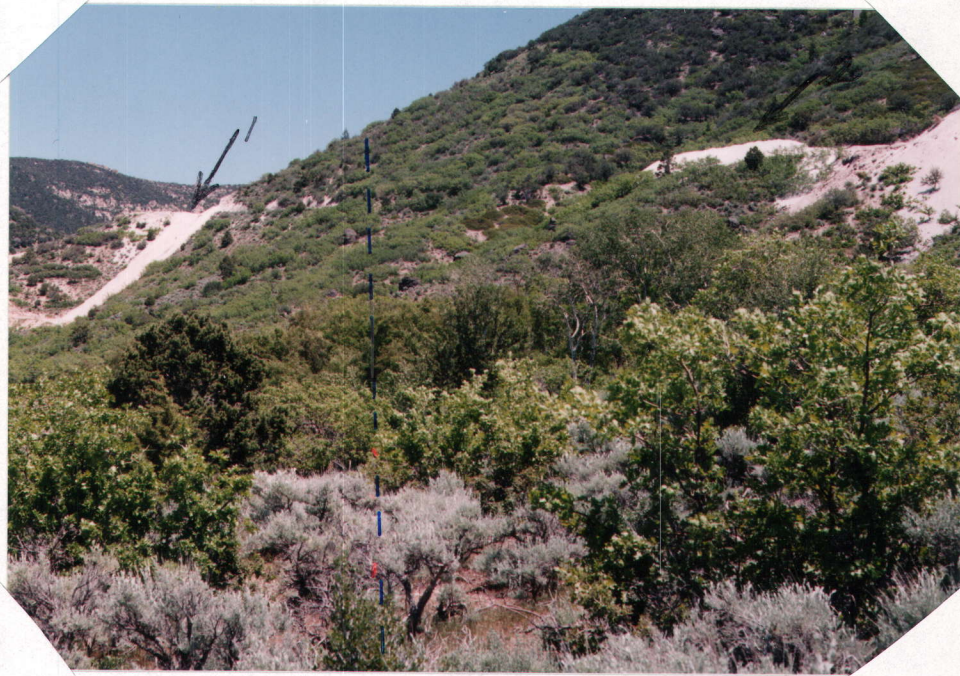
Photo. # 1, The dashed line follows the trace of the south section line of section 36, T. 27 S., R. 9 W. Arrow # 1 shows the location of mine disturbance on the Lopez lease in the SE $\frac{1}{4}$ SW $\frac{1}{4}$ of section 36. Arrow # 2 shows the location of mine disturbance apparently associated with Bradshaw Perlite and Pumice on BLM land in the NW $\frac{1}{4}$ NW $\frac{1}{4}$ of section 1 of T. 28 S., R. 9 W.

The only area of apparent active mining on the Lopez leased lands is located in the SE $\frac{1}{4}$ SW $\frac{1}{4}$ of section 36. (See Map 1) Photo # 1 shows the relationship of the Lopez mined area with respects to the common section line of section 36 in T. 27 S., R. 9 W. and section 1 in T. 28 S., R. 9 W. Photo. # 2 is an attempt to show the various surface disturbances that are associated with the Lopez mining activity in the SE $\frac{1}{4}$ SW $\frac{1}{4}$ of section 36. The approximate area of mine related disturbance on the Lopez lease was determined by pacing the average width and length of each disturbance. The approximate area of mine related disturbance is as follows: (Refer to Photo # 2)

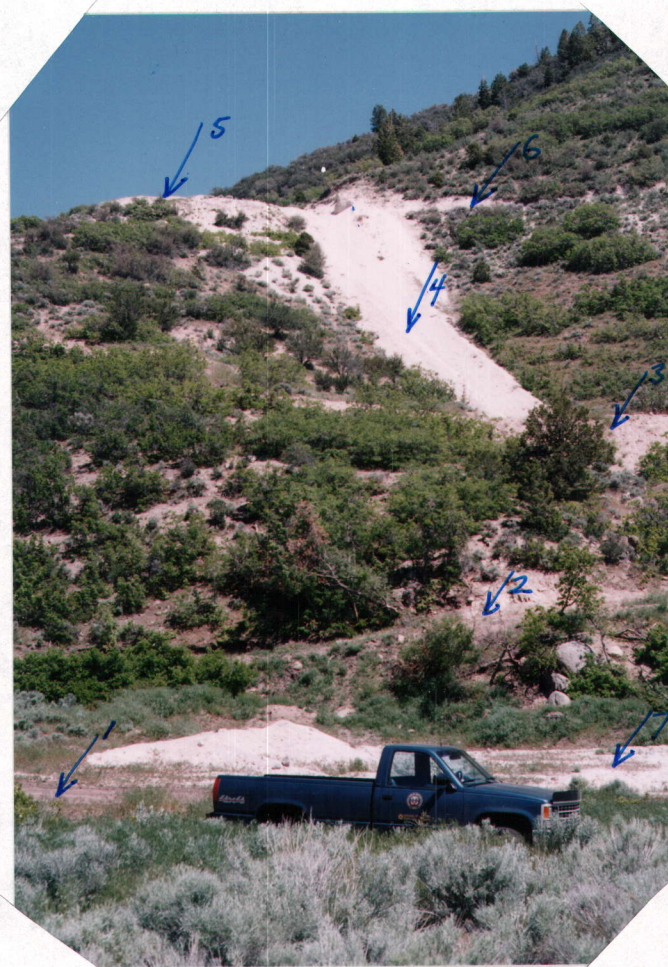
Photo. # 2, Looking southeast on to the Lopez² mine. Arrow # 1 shows the location of the main access road up Ranch Canyon. The Truck is parked on a bulldozed turnout road that falls within the area of the Bradshaw lease ML-40198. Arrow # 2 shows the access road that leads to a materials loading area that is depicted by arrow # 3. Arrow # 4 shows a materials slide, down which material is pushed from the main mined area shown by arrow # 5. Arrow # 6 shows the old access road that has been blocked off by the Bradshaw mining activity in section 1. The BLM does not consider this old access road part of any mine disturbance as it is a pre-existing road. Arrow # 7 shows a loading and stockpile area that is next to the main access road up Ranch Canyon. Another road, which is not shown in this photo, is on the east side of the hill on which the Lopez quarry is located. This road also provides access to the main quarry site.

Main road turn-out, 15'X210' = 3,150 sq ft = .072 Acres

Stock pile next to main road, 60'X168' = 10,080 sq ft = .23 acres

Road to bottom of slide, 15'X500' = 7,500 sq ft = .172 acres
Bottom of slide loading area, 135'X100' = 13,500 sq ft = .31 acres
Slide, 300'X25' = 7,500 sq ft = .172 acres
Main excavation area, 150'X100' = 15,000 sq ft = .34 acres
East side road access, 15'X900' = 13,500 sq ft = .31 acres

Total estimated area of mine related disturbance on the Lopes lease is 1.606 acres.

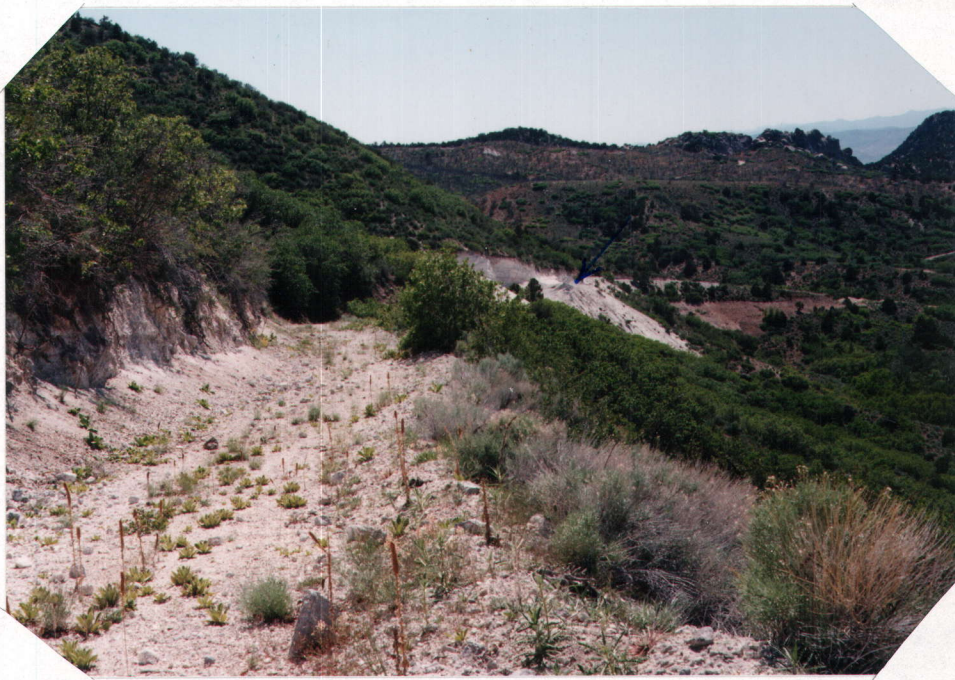
Photo. # 3, Looking southwest along the old access road between the Bradshaw mine (Arrow) in the NW $\frac{1}{4}$ NW $\frac{1}{4}$ of section 1, T. 28 S., R. 9 W. from the Lopez main mine area. The BLM does not consider this road as a mine related disturbance and is thus not subject to reclamation.

Photo. # 3 shows the condition of the old road that once provided access to the Lopez mine area from the Bradshaw mine area in the NW $\frac{1}{4}$ NW $\frac{1}{4}$ of section 1, T. 28 S., R. 9 W. This road is not considered to be a mine related disturbance by the BLM as it is a prior existing road and is thus not subject to reclamation.

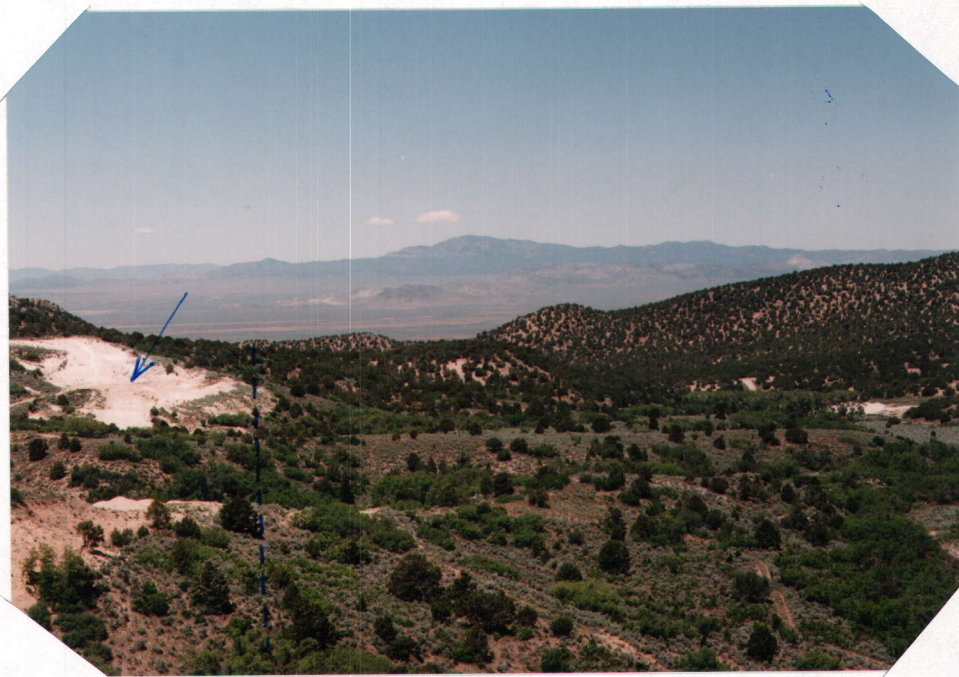
Photo. # 4, Looking west. The dashed line shows the approximate trace of the common section line between section 2, T. 28 S., R. 9 W. and section 35 T. 27 S., R. 9 W. The arrow shows the J & J Masonry mined area. Note; a small portion of the tailings from the J & J mine falls on BLM land in section 35, T. 27 S., R. 9 W.

The only observed mine related disturbance is located in the N $\frac{1}{2}$ of Lots 2. of section 2. (See Map 1) Photo # 4 shows the approximate trace of the common section boundary between section 2, T. 28 S., R. 9 E and section 35, T. 27 S., R. 9 E.

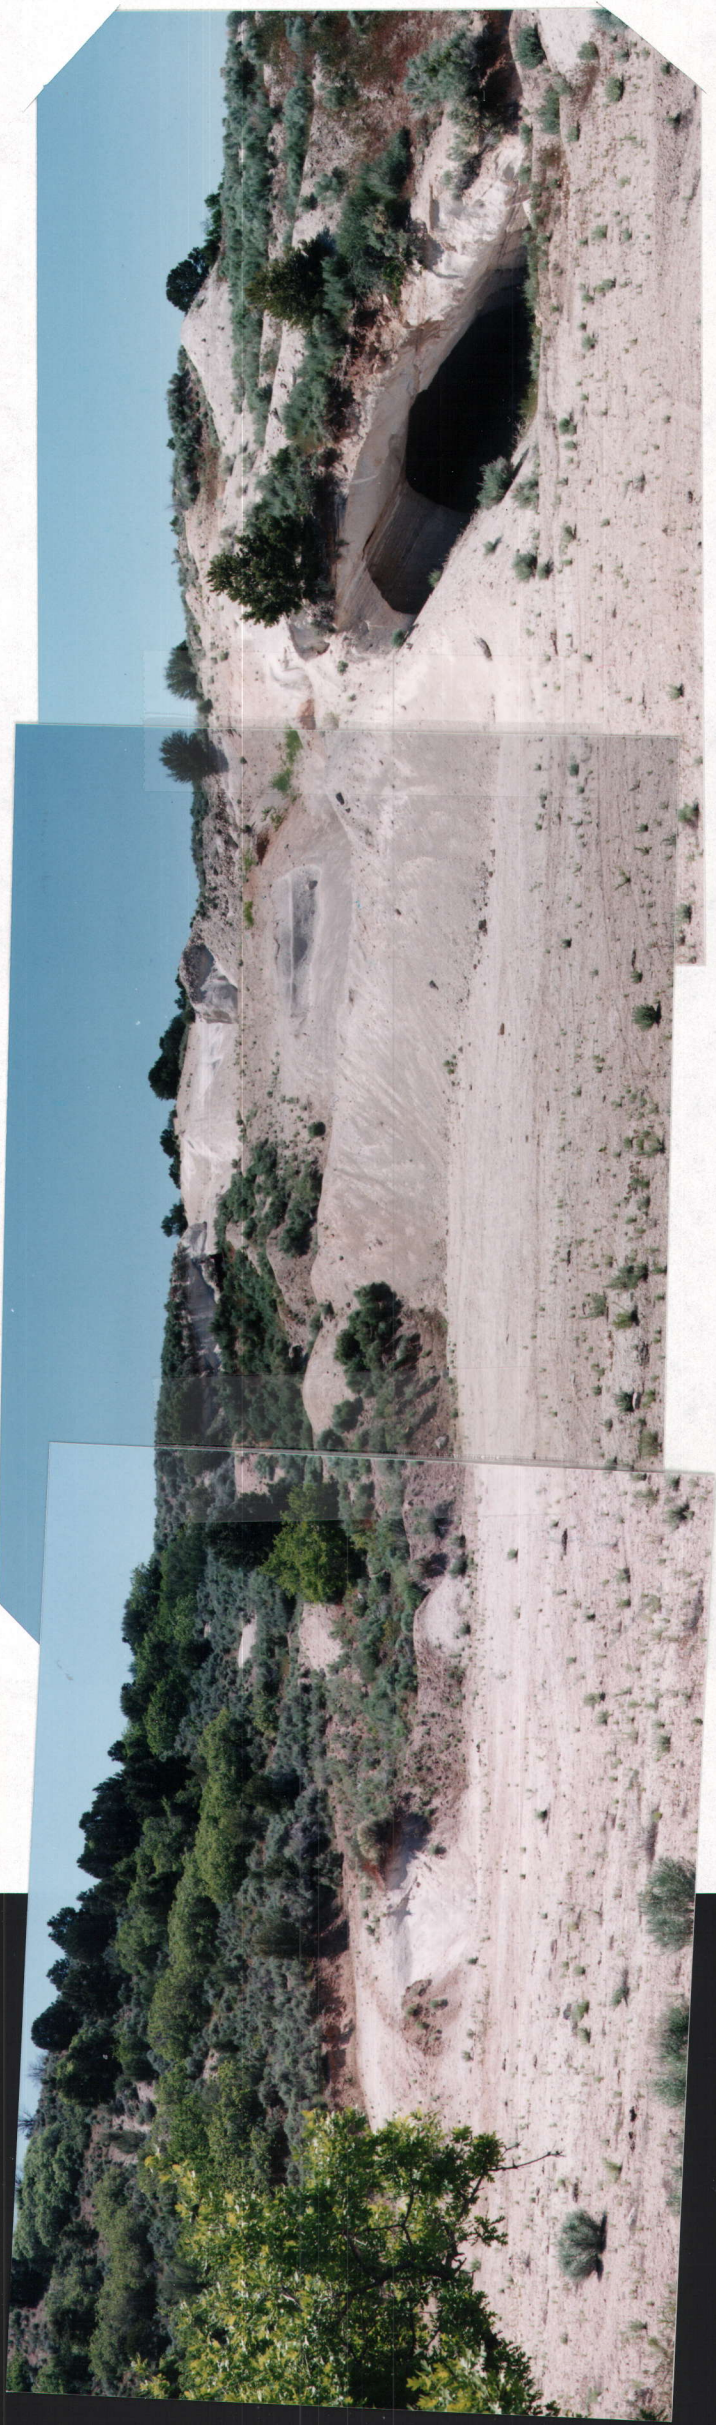
Photo. # 5, Panorama of the J & J mined area. Looking west from the eastern most extension of the disturbed area. Note open adit which was reported closed by the Lessee.

From observations made on the J & J mine site it does not appear that there has been any recent mining activity even though representatives of J & J mining have reported to DOGM annual removal of material from the mine. Photo # 5 shows a panorama of the J & J mine site. The approximate acreage of disturbed area on the J & J mine site is as follows:

Of some concern to DOGM is a small adit and tunnel on the J & J mine site. (See Photo. # 5) The Division of Oil Gas and Mining has requested that this adit be closed and the Lessee has reported that they have done so. As evidenced by Photo # 5 no effort has been made to close this adit.

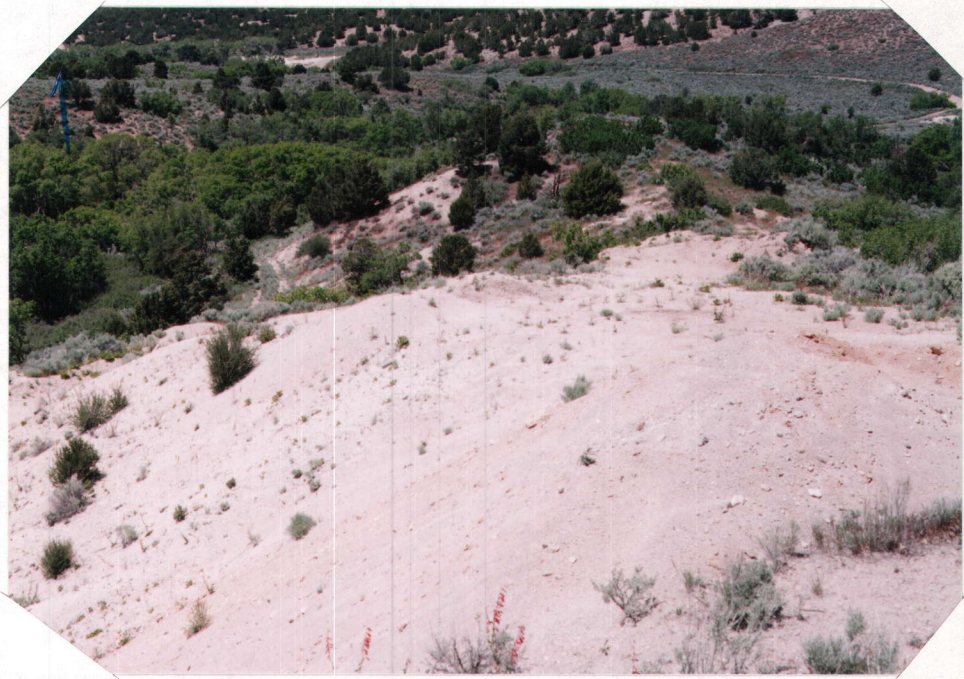
Photo # 6, Looking northwest onto mine related disturbances in the northern most portion of Lot 1, section 2. It is difficult to determine if there has been any recent mining in this area. Bradshaw Pumice and Perlite has identified this area as a proposed mine site. The arrow in the upper left corner of this photo shows the location of a large stockpile of pumice which is near the main access road to Ranch Canyon and is on BLM land.

Mine related disturbances on Lot 1 of section 2 include areas where material has been removed, sorted and stockpiled. Photo # 6 shows a disturbance that Bradshaw has identified as a proposed mine site on topographic maps submitted to SITLA. This disturbance, which will be referred to as the "point disturbance", is in the northern most part of Lot 1 and has obviously been the site of past mine related activity. It is difficult to determine if there has been any recent mine related activity in this area. Photo # 7, which is taken from the point disturbance shows other mined areas and stockpiles that are within the boundaries of Lot 1, section 2.

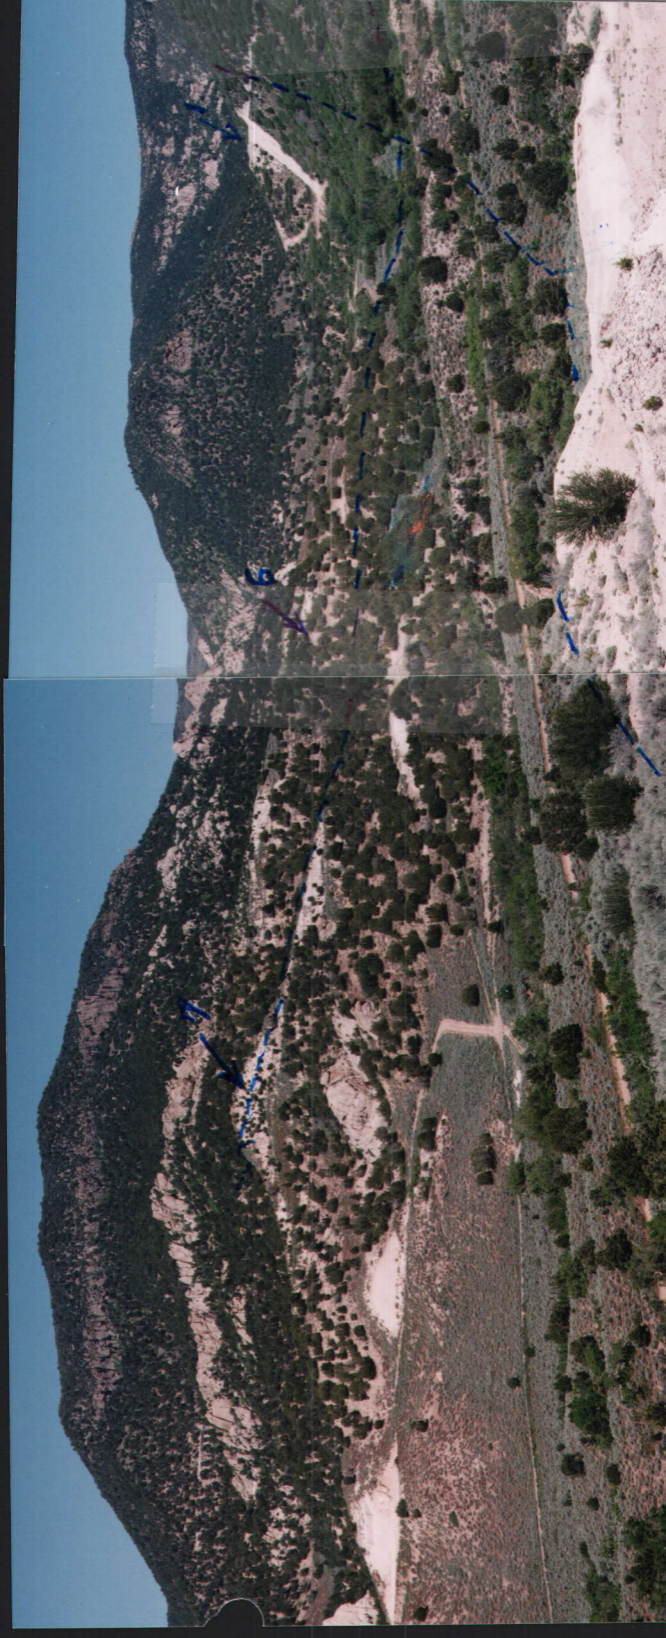
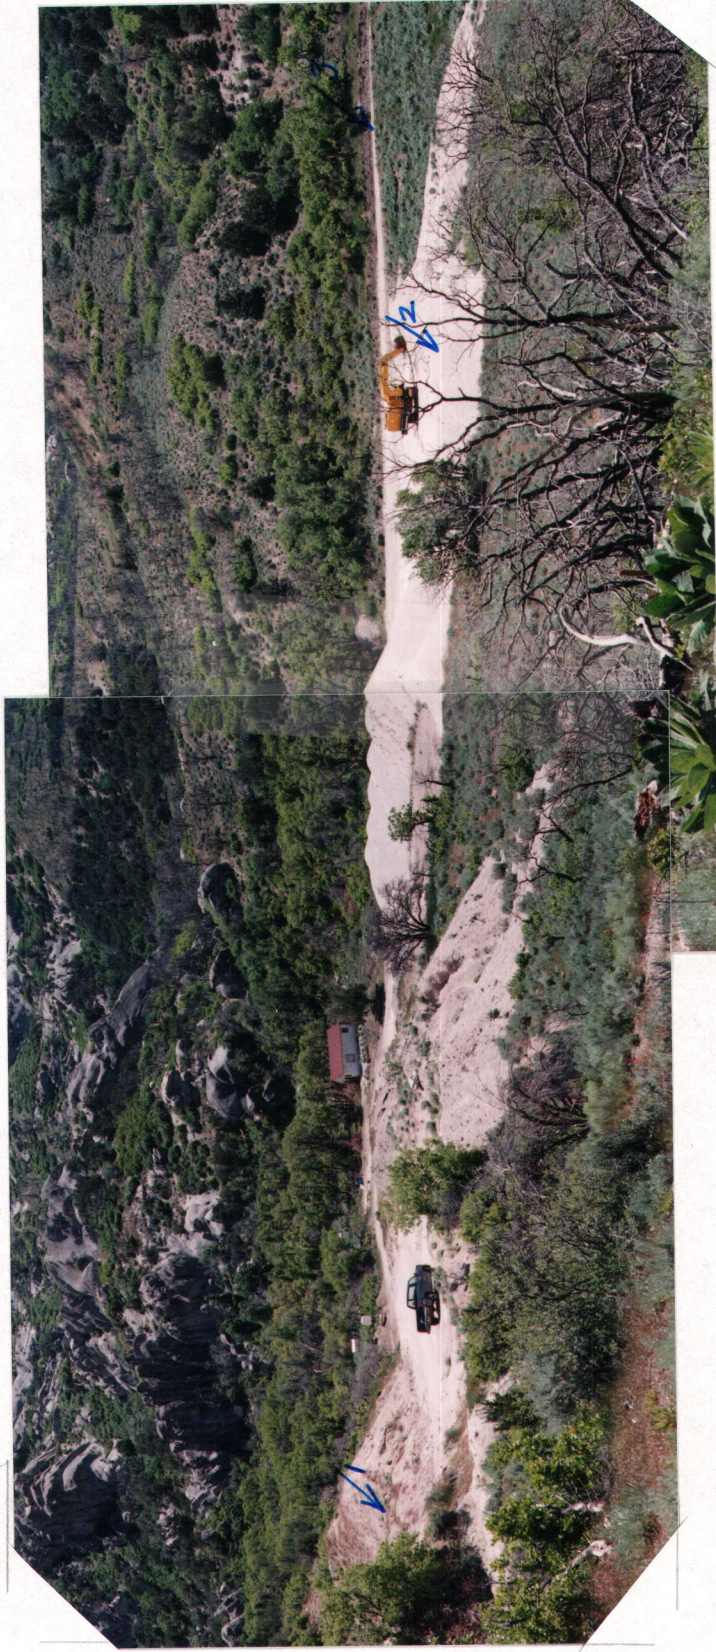
Photo. # 7, Panorama looking southwest from the "point disturbance" area, as shown on Photo # 6, onto other mine related disturbances on Lot 1 of section 2. Arrow # 1 shows the location of what has been identified by Bradshaw Pumice and Perlite as the Mt. View Survey # 2 site. Arrow # 2 is the location from which Photo # 8 was taken. Arrow # 3 is the main access road to this site which is not included in the total mine related disturbances found on Lot 1 of section 2. Note cabin that has been constructed on the site.

Lot 1, Mt. View # 2 and adjacent land, 210'X300' = 63,000 sq ft = 1.45 acres (See Photo # 7)

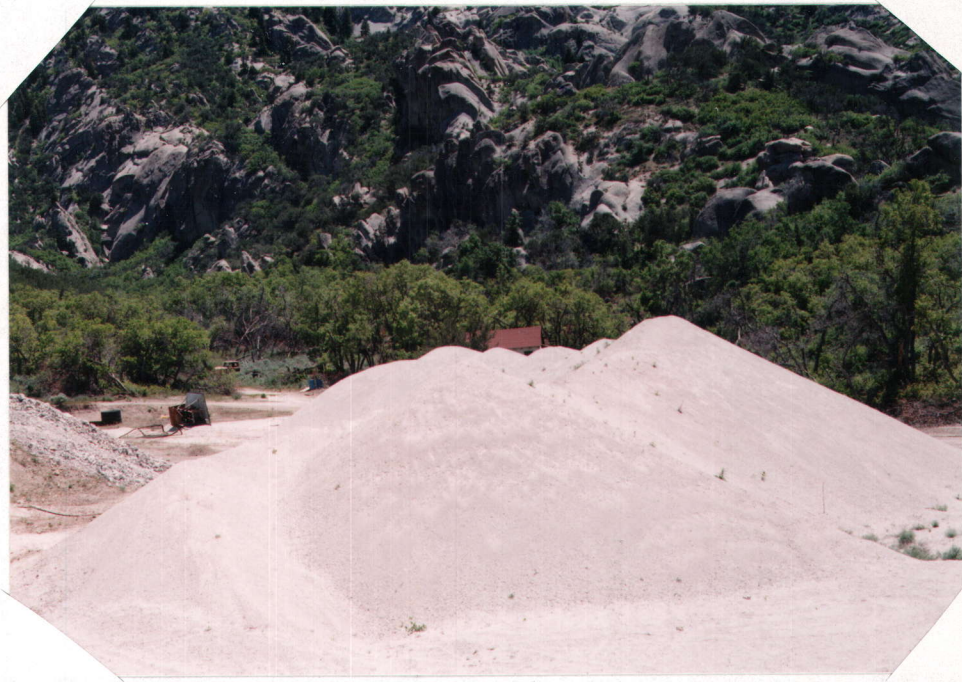
Photo. # 8, Looking south from the northern most extension of the stockpile area found on the Bradshaw lease on Lot 1 of section 2.

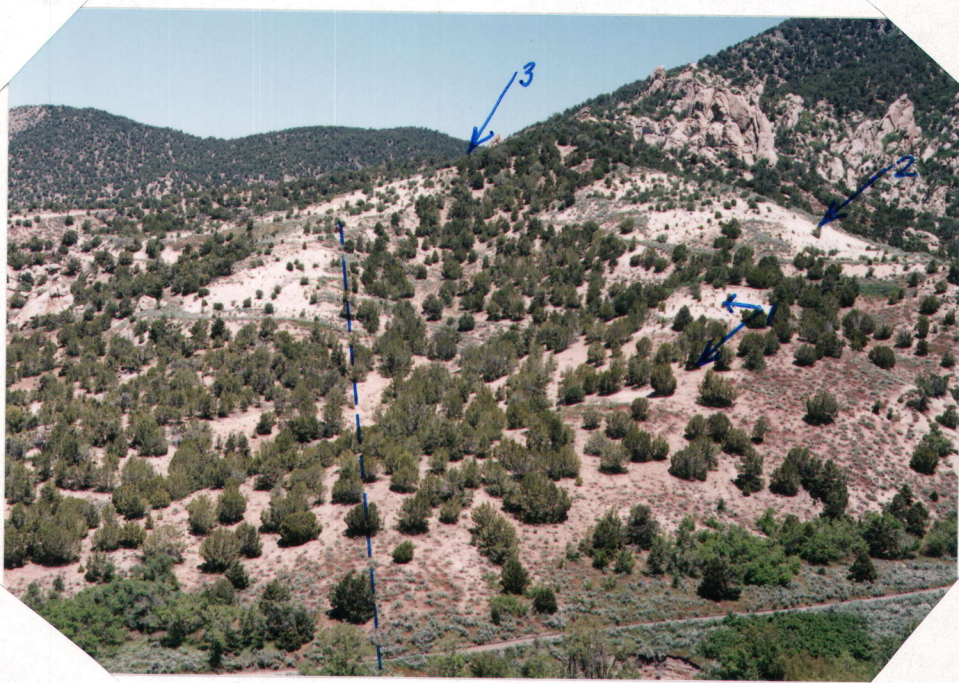
Photo. # 9, Looking north along the trace of the common section line between section 35, on the left, and section 36, on the right. Arrow # 1 shows the approximate location of a proposed mine site that has been submitted, on a topographic map, by Bradshaw Pumice and Perlite. Arrow # 2 shows the location of a old re-vegetated mine site that shows no evidence of mining activity and is indicated on Map 1 by the word "old". This old mine site is also shown in photo # 10. Arrow # 3 shows the approximate positions of proposed mine sites on Bradshaw lease ML- 41353 which is just over the hill in this photograph.

A proposed mining area within ML-40198, the W $\frac{1}{2}$ SW $\frac{1}{4}$ of section 36 is marked on Map 1 with a "T". This proposed site lies very near an old disturbance that shows no evidence of recent mining activity and is partially re-vegetated. (See Photos # 9 & 10.)

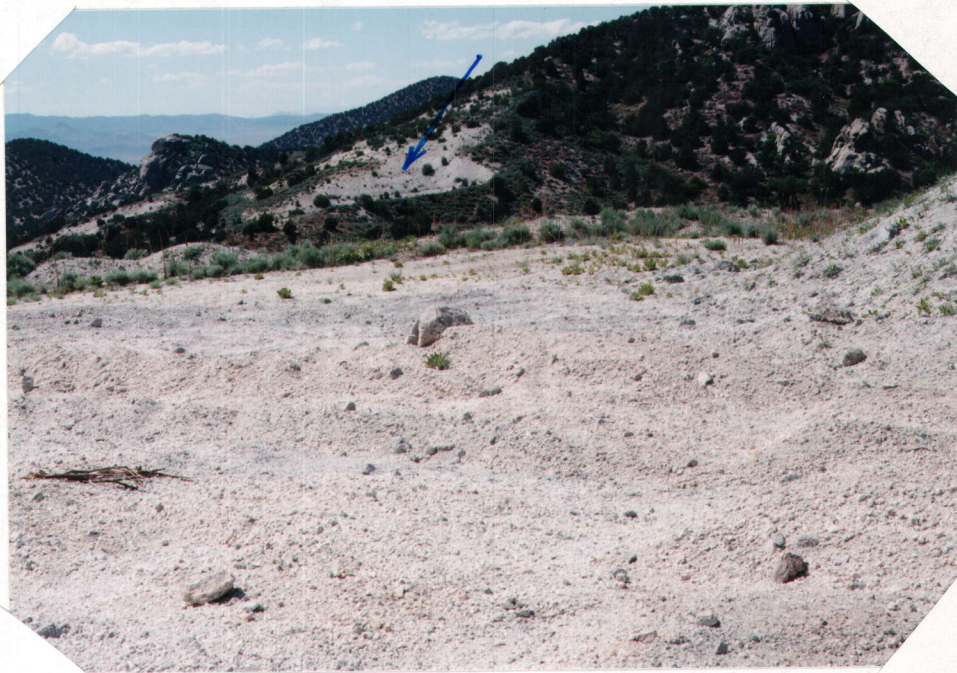
Photo. # 10, Looking southwest from the main mine area on the Lopez lease, ML- 35683, onto the "old" mine site which falls on Bradshaw lease ML-40198.

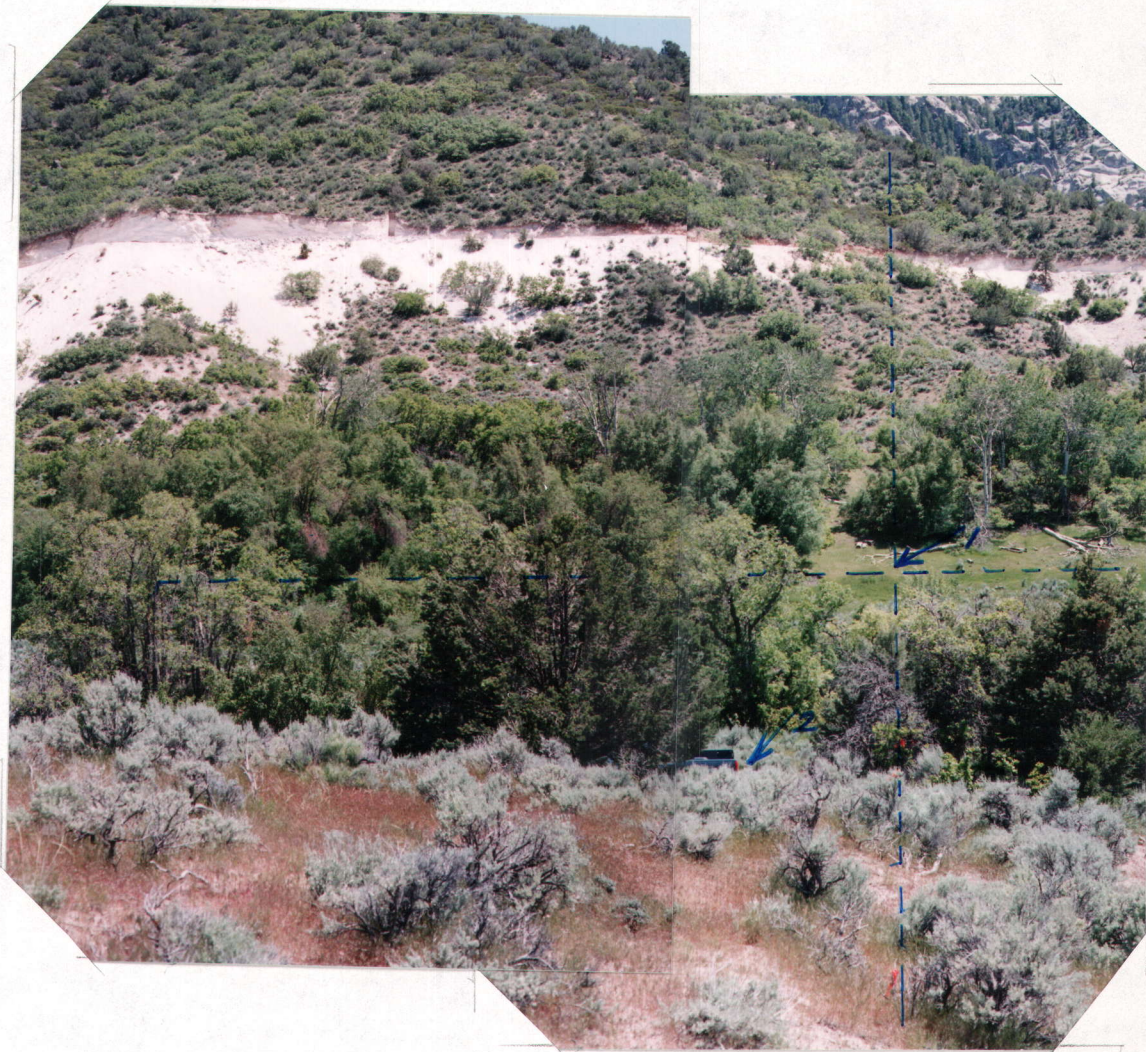
Photo. # 11, Looking south onto the common section corner of section 1 (upper left corner) and section 2 (upper right corner) of T. 28 S., R. 9 W., and section 35 (lower right) and section 36 (lower left). Arrow # 1 shows the location of the section corner monument. Note the large disturbance on the hill which is believed to be part of the Bradshaw Pumice and Perlite mining activity in section 1. Arrow # 2 shows the location of the truck which is parked on the main access road in Ranch Canyon.

Accompanying this report are photographs #'s 11 and 12 which show various features as discussed in the body of this report.

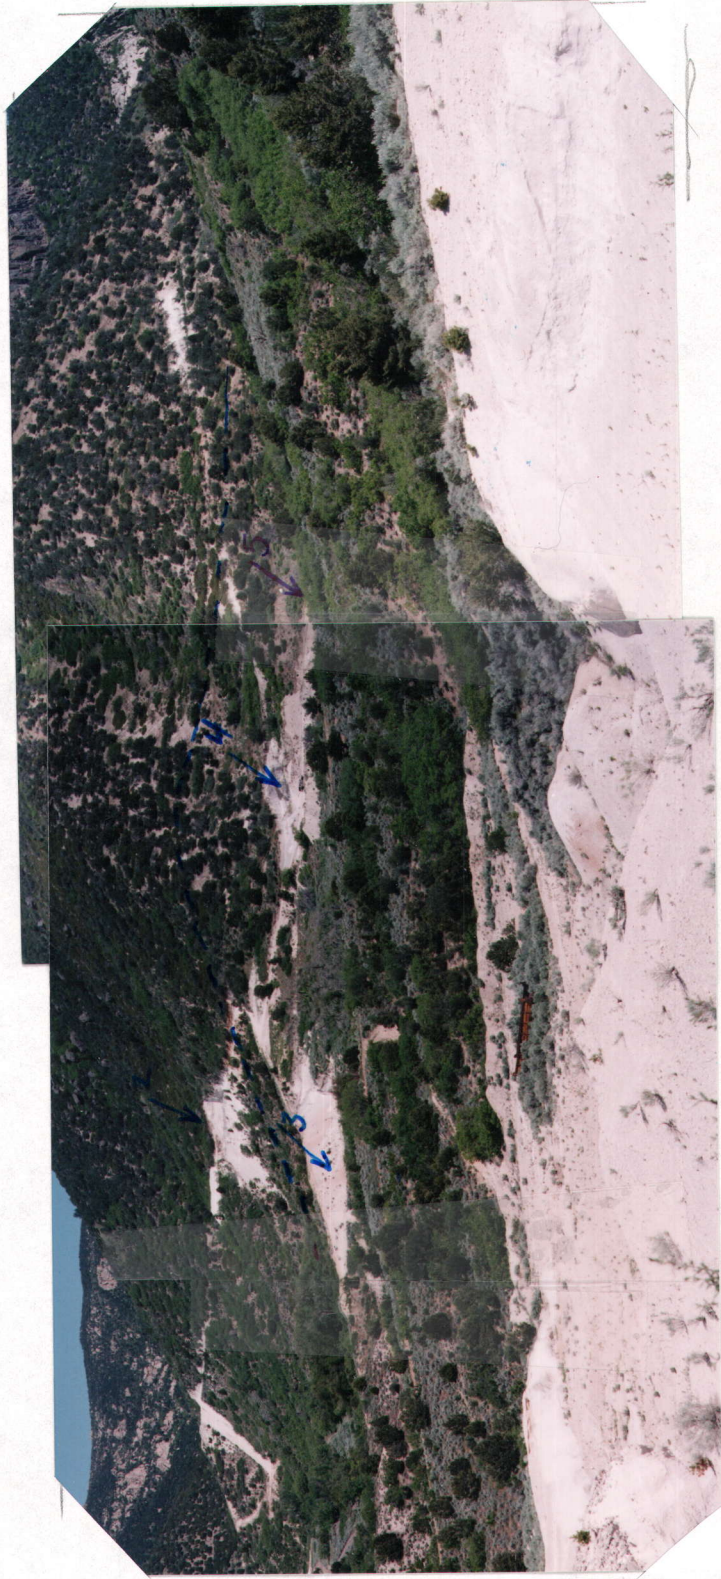
Photo. # 12, Panorama of many of the features discussed in this report. Looking east from the mine disturbance at the J & J mine site in Lot 2 of section 2 in T. 28 S., R. 9 W. The dashed lines show the approximate trace of the section lines which are projected from the common section corner which is also shown in Photo. # 11. Arrow # 1 is the Lopez mine site in the SE $\frac{1}{4}$ SW $\frac{1}{4}$ of section 36. Arrow # 2 is the Bradshaw mine area in the NW $\frac{1}{4}$ NW $\frac{1}{4}$ of section 1. Arrow # 3 is the Bradshaw mine disturbance referred to as the "point disturbance" in the northern part of Lot 1, section 2. Arrow # 4 is Bradshaw disturbance referred to as the Mt. View Site # 2. Arrow 5 shows the location of the Bradshaw stockpile area. Arrow # 6 is the Bradshaw proposed mine site on ML-40198, W $\frac{1}{2}$ SW $\frac{1}{4}$ of section 36. Arrow # 7 is the surveyed proposed mine site on ML-41353, W $\frac{1}{2}$ NW $\frac{1}{4}$ section 36.
